**3rd Meeting of the Compliance and Technical Committee
Valdivia, Chile, 21 to 23 January 2016**

**CTC-03-05
DRAFT IUU List**

Preliminary investigation report – Operations Branch, New Zealand Ministry for Primary Industries

Russian flagged vessel *Mys Marii* undertakes alleged IUU fishing in South Pacific Regional Fisheries Management Organisation (SPRFMO) Convention Area.

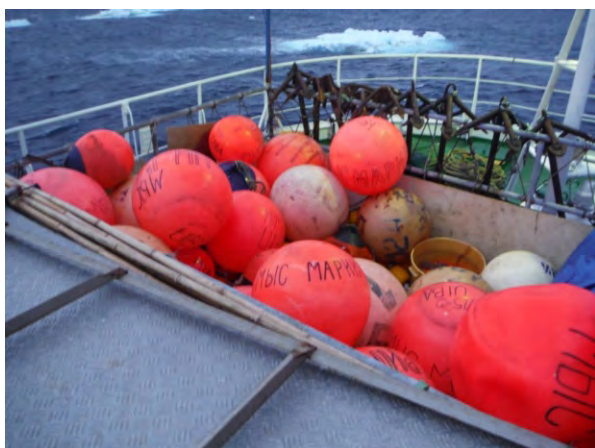
Photo 1 – photos taken of bottom longline gear when the *Mys Marii* was inspected by a New Zealand OPV on 1/12/2014 in the CCAMLR Area

On 12 December 2014, the *Mys Marii* was inspected by a New Zealand Navy Offshore Patrol Vessel (OPV) while fishing in Statistical Subarea 88.1 (Ross Sea) of the CCAMLR Area. The inspection of the vessel did not reveal any matters of non-compliance with CCAMLR Conservation Measures (CMs). During the inspection, it was recorded that the vessel was using demersal (on the seabed) longline gear (which is shown in Photo 1) and no other gear was seen on board the vessel.

2. Photo 1 shows that the vessel was using only bottom longlining (BLL) gear in the Ross Sea CCAMLR fishery prior to arriving into the Louisville Ridge area within the SPRFMO Convention Area. The vessel did not have an opportunity to change methods on route. It is highly likely therefore that the vessel was deploying BLL gear when operating in the Louisville Ridge area within the SPRFMO Convention Area.

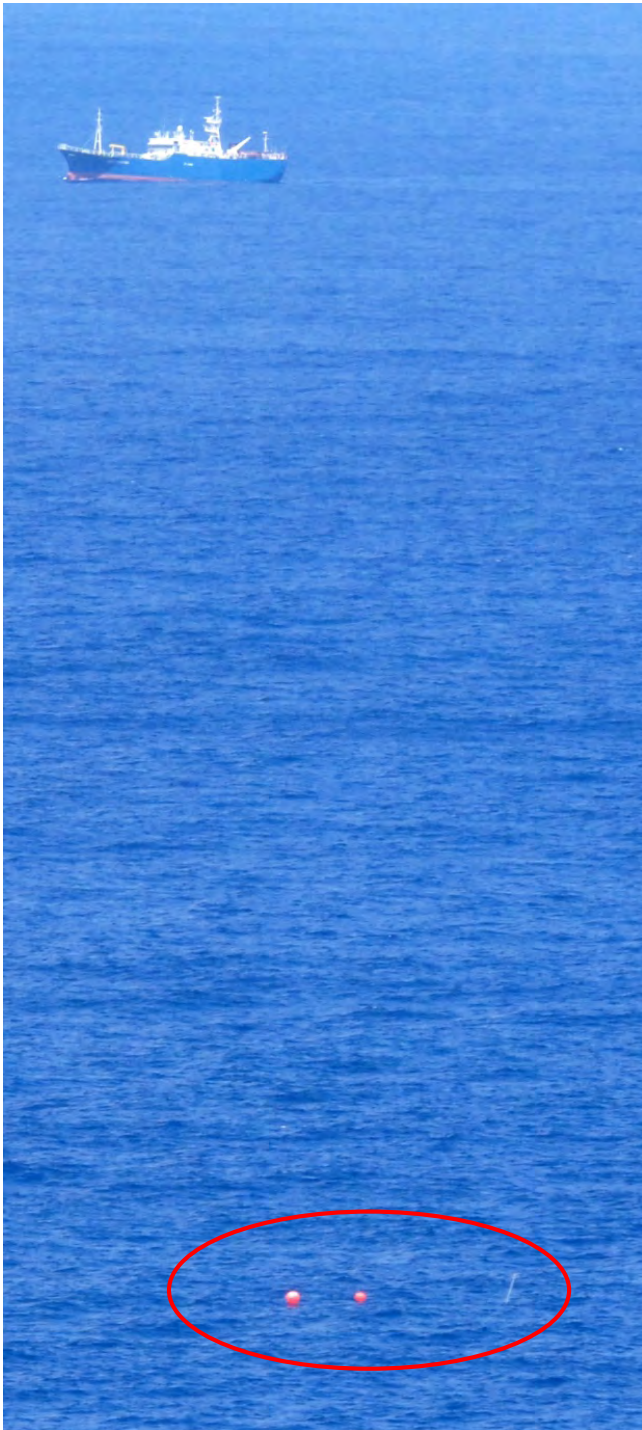
Photo 2 (left, taken 21/2/2015 @ 1208 NZDT) – *FV Mys Marii* approaching from a distance the set of buoys and associated fishing lines (in red circle). **Photo 3 (right, taken 21/2/2015 @ 1155 NZDT)** shows vessel markings on the floats indicating the letters '*Mys Marii*'

6. Photo 2 show the *Mys Marii* locating and closing in on a set of deployed buoys and radio beacon that are attached to a bottom long line
7. Photo 3 shows a marking on one of the deployed buoys that reads *Mys Marii*.

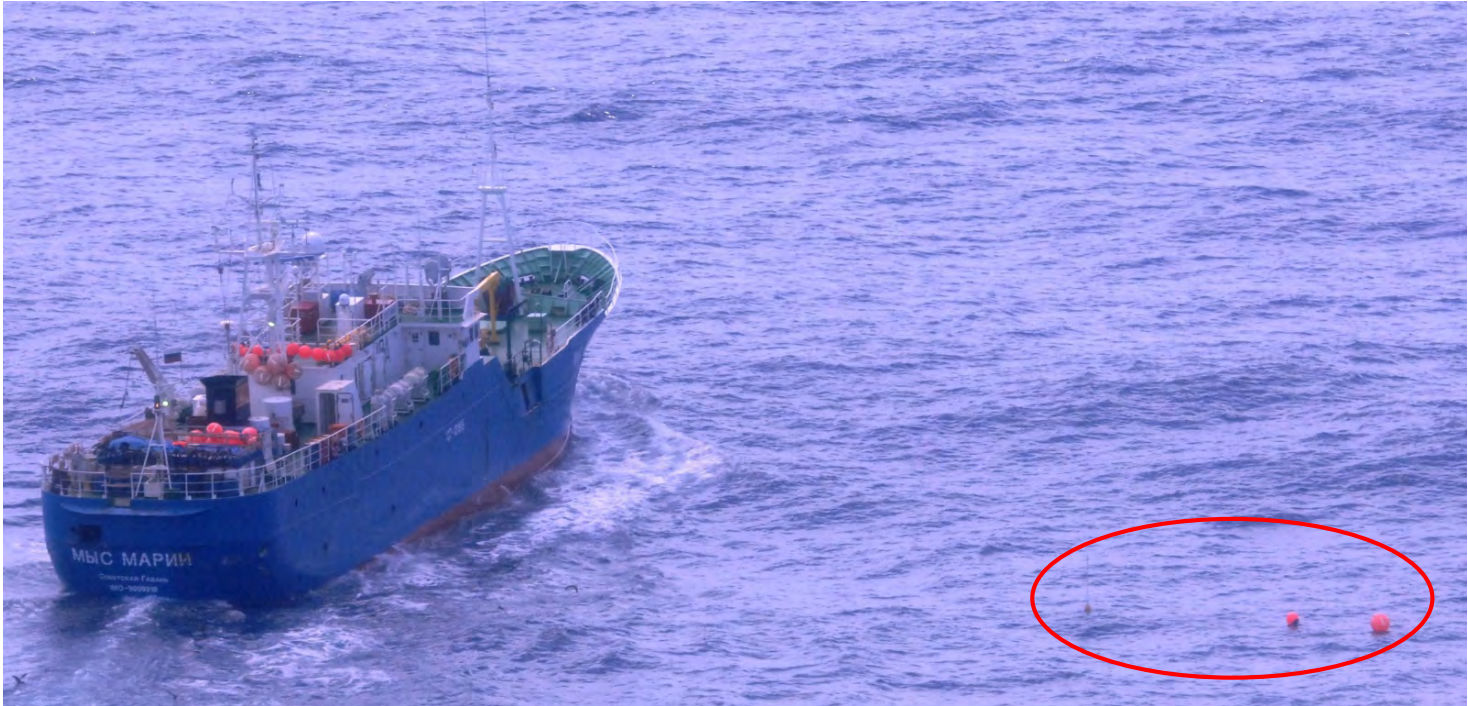
Photo 4 (21/2/2015 @ 1315 (NZDT) – FV *Mys Marii* coming alongside and manoeuvring to retrieve buoys and longlines before hauling them

8. Photo 4 shows *Mys Marii* manoeuvring into to haul the bottom longline
9. Photo 5 shows *Mys Marii* hauling the bottom long line gear from the starboard hauling door (below wheelhouse). The buoys and radio beacon are in clear view and match exactly those that were previously observed

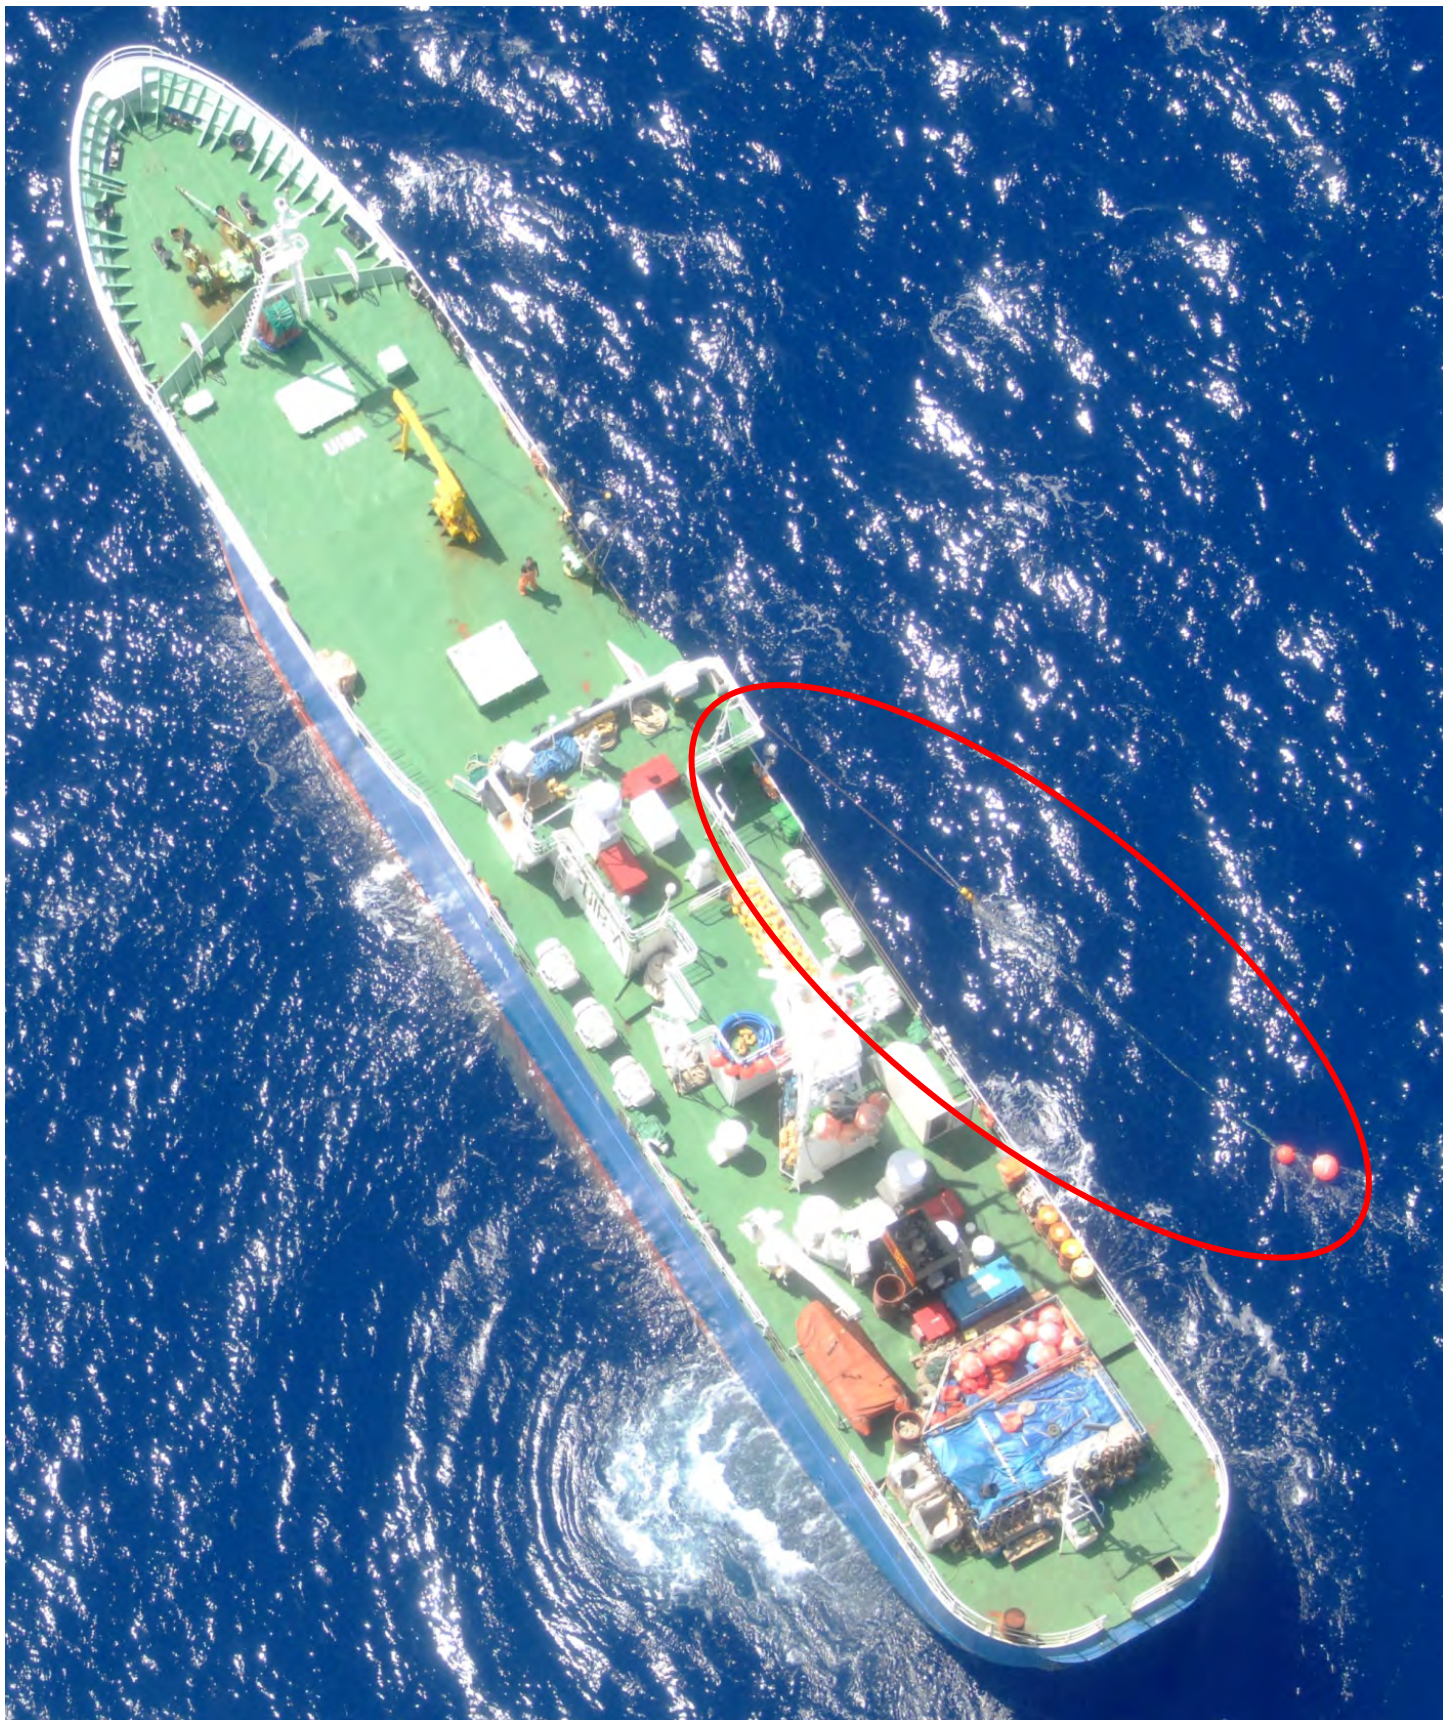
Photo 5 (21/2/2015 @ 1325 (NZDT) – FV Mys Marii hauling radio beacon, buoys and longlines
