Subject: Results of inspection of vessel *Lafayette* in the port of Las Palmas, 2-3 December 2011.

Technical Report Lafayette

Review of photographic evidence to determine active
pair trawling capability for the

MV Lafayette

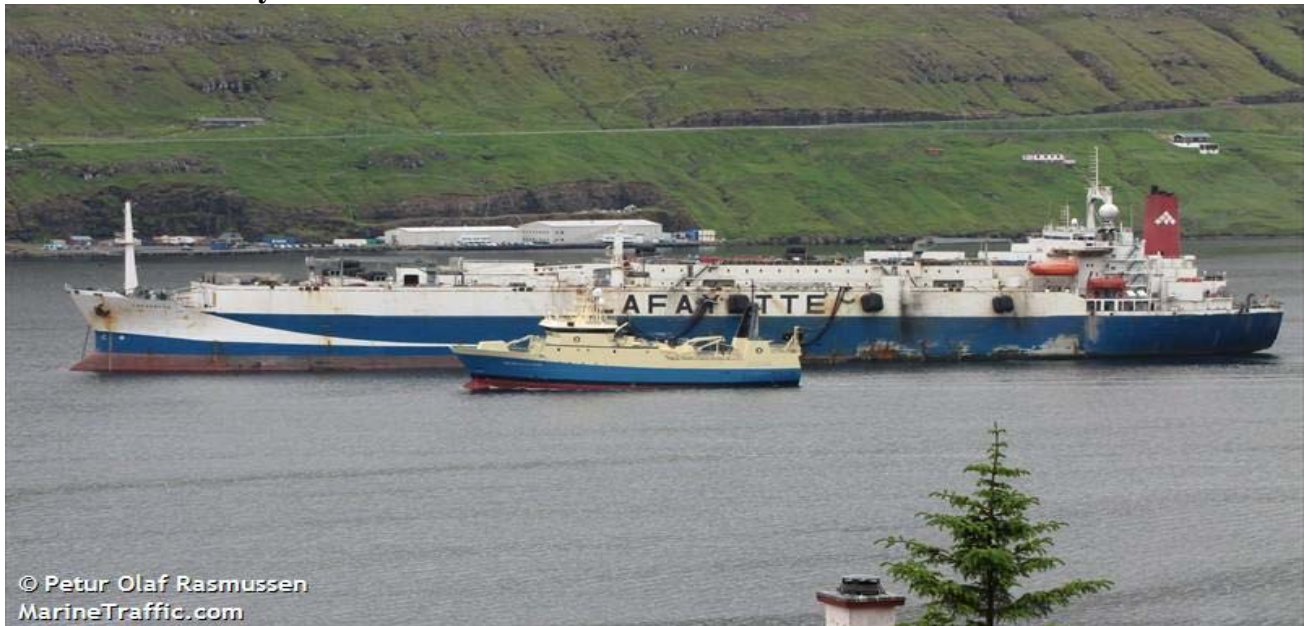
Picture No.1: Lafayette at anchor in Faroe Islands 2011

Picture No. 1 is of the Lafayette with a Faroese fishing vessel (Arctic Viking, 58.00 metres LOA, 13.00 metres Beam and 1720 tonnes GT), alongside Lafayette's port side (in the vicinity of one of the two port side pumping stations), and aptly demonstrates the bulk and size of Lafayette. Arctic Viking is the size of fishing vessel normally encountered fishing in the NAFO and NEAFC areas, which in 2-3 months fishing, can catch, and carry 500 to 600 tonnes of processed fish (about 700 tonnes live weight equivalent).

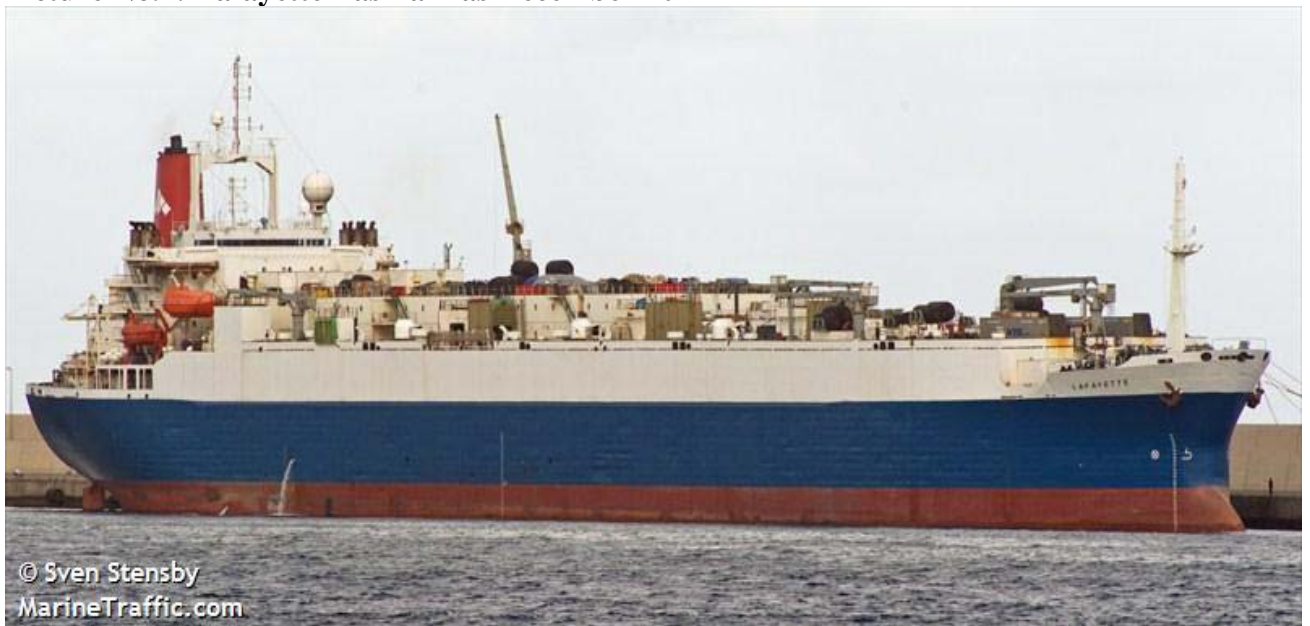
Picture No.2: Lafayette Las Palmas December 2011

Picture No.2 is of the vessel alongside Reina Sofia pier in Las Palmas following repainting, and illustrates the how it has been transformed from oil tanker to "fishing vessel/fish factory vessel". The factory area is positioned within the white painted area extending forward from the bridge superstructure to the bow position aft of the foremast. Below this area, in the are painted blue, are the refrigerated holds and refrigerated sea water tanks in that area previously used to carry oil and petro-chemicals. The draught of the vessel as shown here is approximately 6 metres, and the GT approximately 40, 000 tonnes.

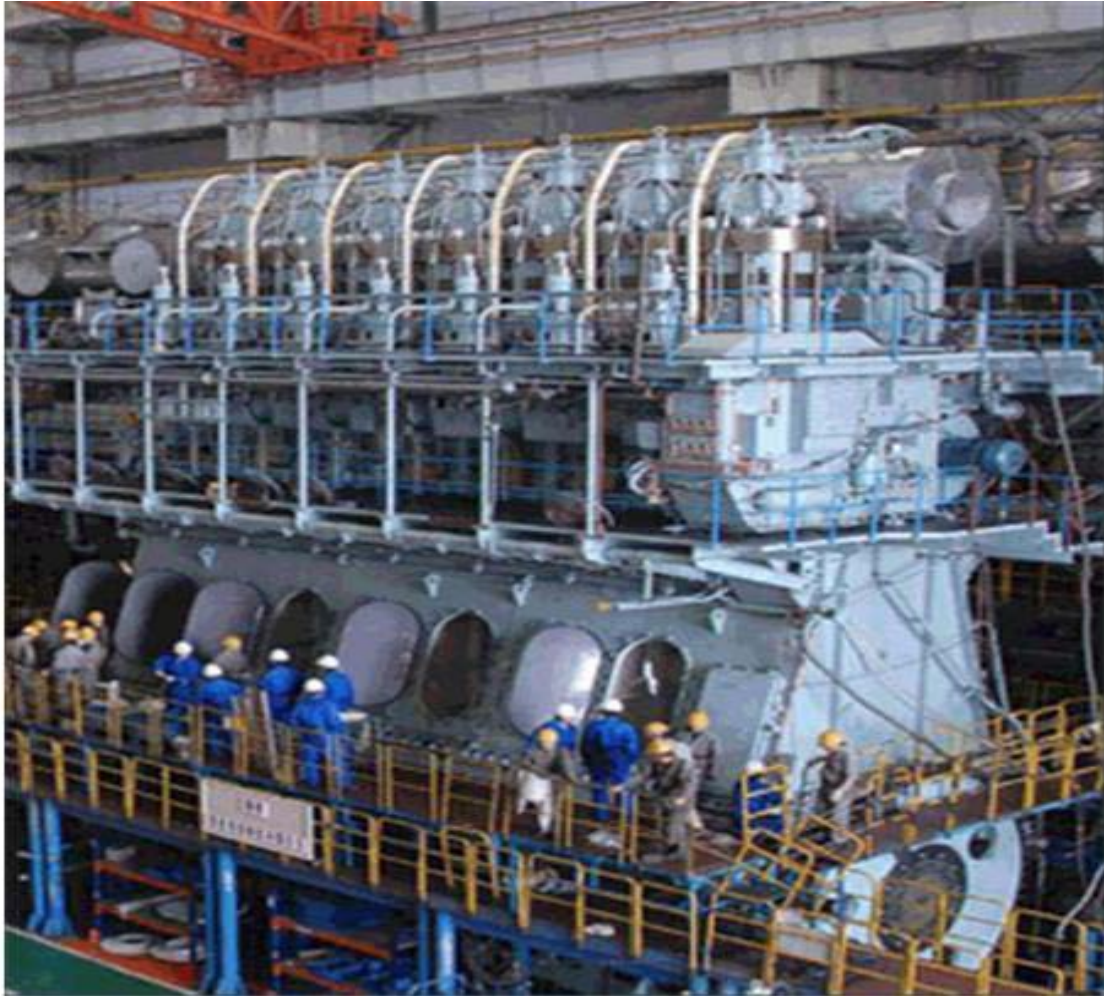
Picture No.3: Marine diesel engine similar to the type fitted to oil tankers

This is a typical two stroke diesel engine of a type expected to be found in an oil tanker of this size. These engines are physically very big being about 5 metres high. They are very heavy with a large internal mass moving up and down at a slow rate of rotation (122 RPM maximum). It is an engine designed for work in a stable and continuous regime, such as would be found during very long ocean voyages. The economy peak is found therefore at points approaching the maximum RPM.

Picture No.3 is of a similar size engine and the comparative sizes of men working around it demonstrates the dimensions and mass of these engines.

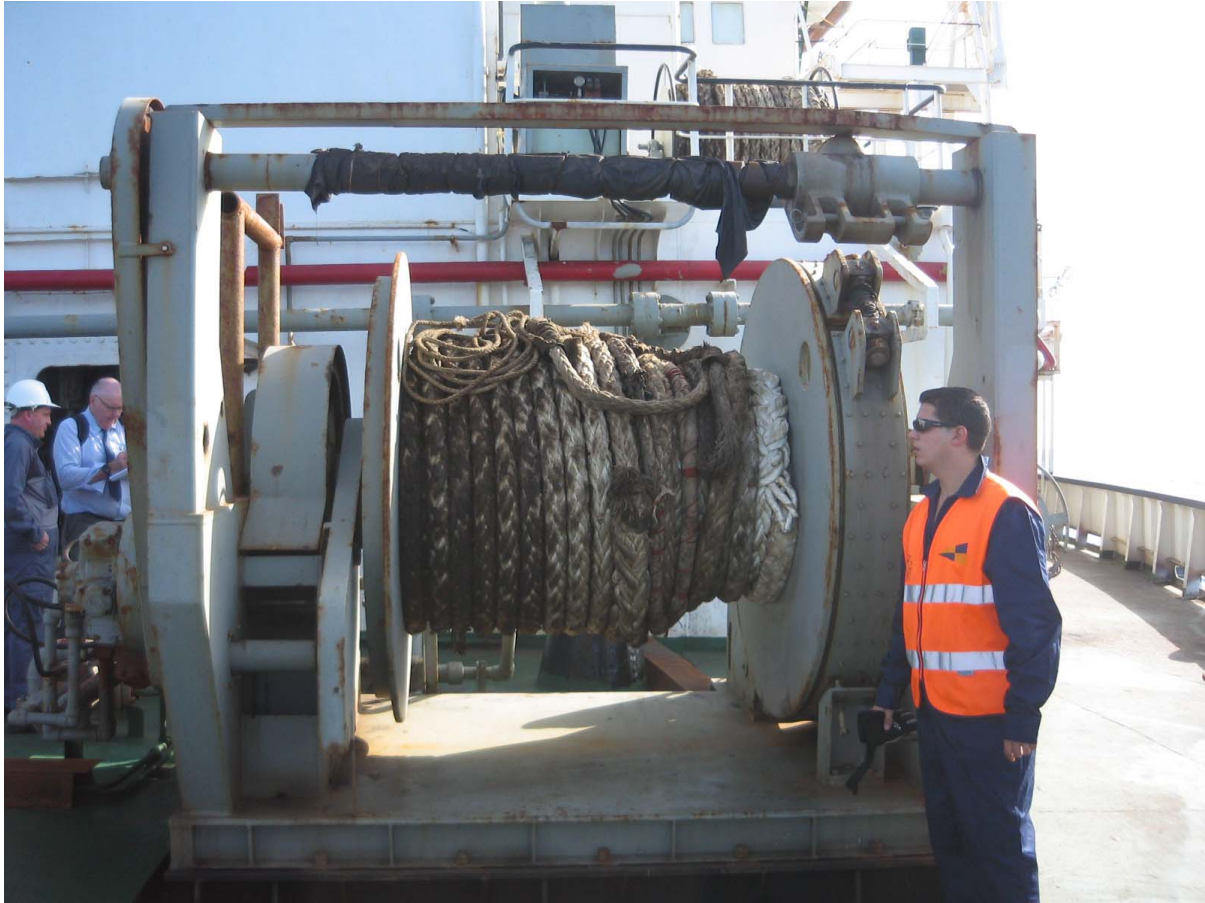
Picture No. 4: Winch fitted to stern main deck area aft port side Lafayette

A winch is installed (see Picture No. 4 below) in the port quarter station on the stern deck at main deck level. The plate on this winch shows that it is a Funz San hydraulic towing winch, model WO 135 with a capability rated at 60 tons x 28 metres on the first layer and 25 tons times 67 metres on the second layer. Irrespective of the quantity (length of warp) which it could accommodate, it is alleged that the vessel tested the winch shown in pair trawling trials in the Pacific during 2010. The current Master at the time of the inspection in Las Palmas but who was not on board in the Pacific in 2010, stated that a rope of 26 mm had been used, but that the result was inconclusive and the experience had not been repeated. This was supported by comments made by the then Master during the inspection of the vessel by the French Polynesian authorities in 2010, and who stated that it would not work.

Theoretically at least the Lafayette could operate as a member of a pair trawl team. However, putting aside for one moment seamanship problems associated with a vessel of this size operating in close quarters at low speed and manoeuvring to pass and recover pair trawl gear, the vessel does not appear to have, or has had, any capacity to haul a net aboard or to handle a pair trawl and associated gear of the size used by the larger fishing trawlers in the small pelagic fisheries with Lafayette was associated with. Irrespective of the lack of suitable towing points for a trawl warp, there are only limited control facilities for this winch. There are no warp tension-meters fitted anywhere either in stern area adjacent to the winch or in the wheelhouse itself, and there are no fishing sonar or fish finding devices to be found.

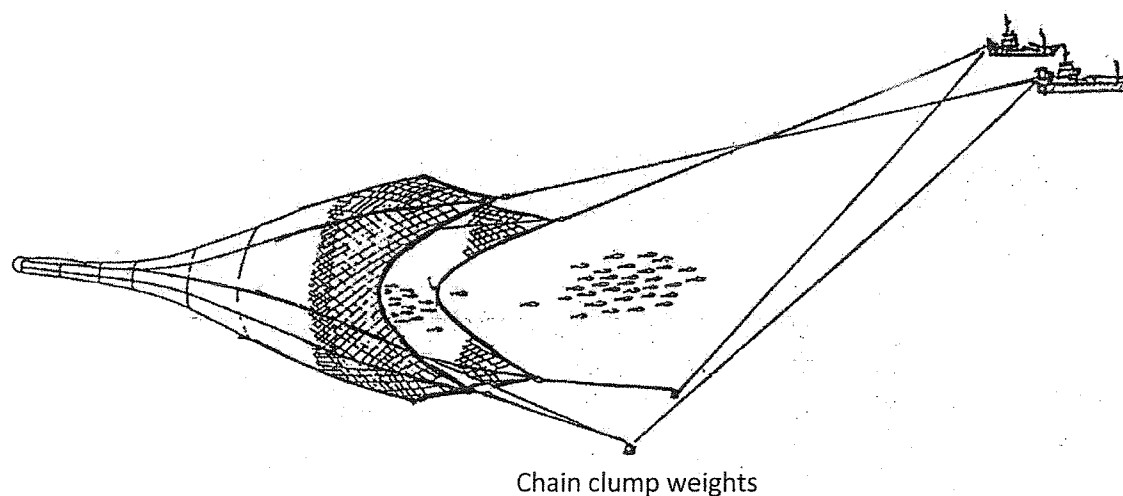
Pelagic or midwater trawls are generally much larger than bottom trawls with the forward sections of the net usually comprising of very large meshes (5-120m) or ropes that herd the shoals of fish towards the main body of the trawl.

The position of the net between the surface and seabed is usually monitored using electronic sensors on the headline to give a depth for both top and bottom of the net allowing the skipper to position his net in line with the shoal. These nets can be as big as 160 metres deep and 240 metres wide.

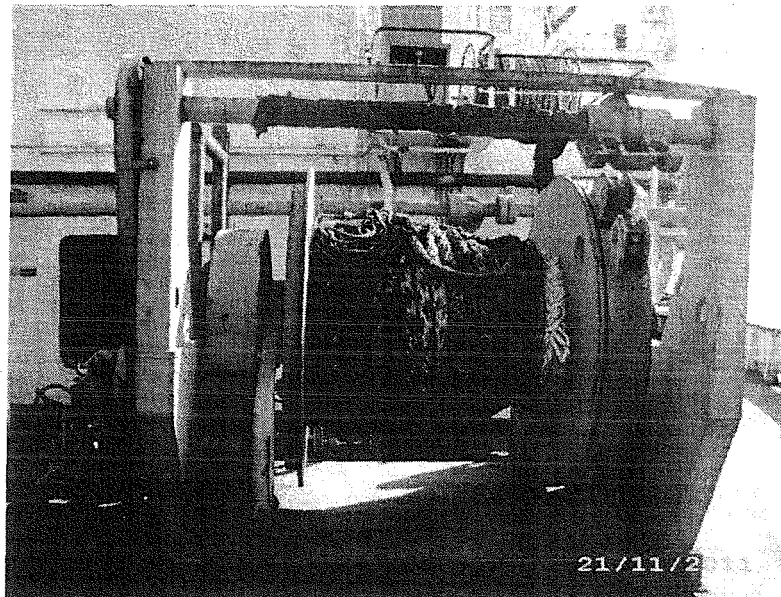
The main trawl winch shown in the photograph below has been taken from another vessel and placed onboard the Lafayette.

The winch arrangement is completely unsuited in its current form for pair trawling. The guide on gear is positioned high above the main winch barrel; it is likely that this winch came from a vessel with a large stern gantry requiring a high lead off angle from the winch.

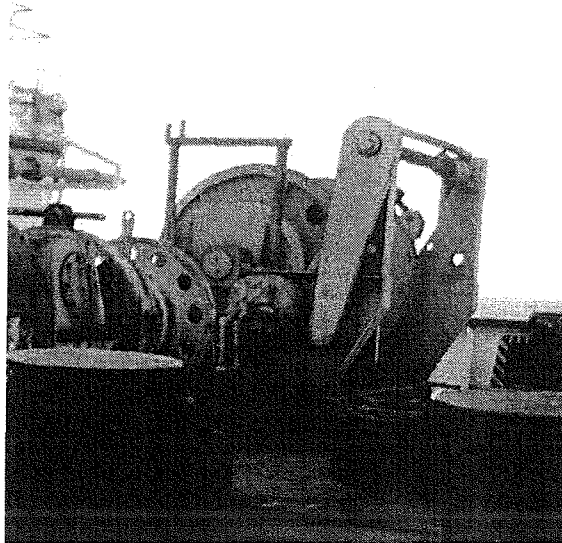
In the current position if the guide on gear was used it would result in significant damage to the winch given that the lead from the winch barrel through the guide on gear and out over the stern of the vessel would result in an almost 90 degree angle as shown in the photograph below. This would place significant loading on the guide on gear. And create a substantial bending moment.
